Bench-scale Treatment Study of Produced Water from the Southern San Juan Basin New Mexico

Kanalis Group

December 1, 2022

Volume 1

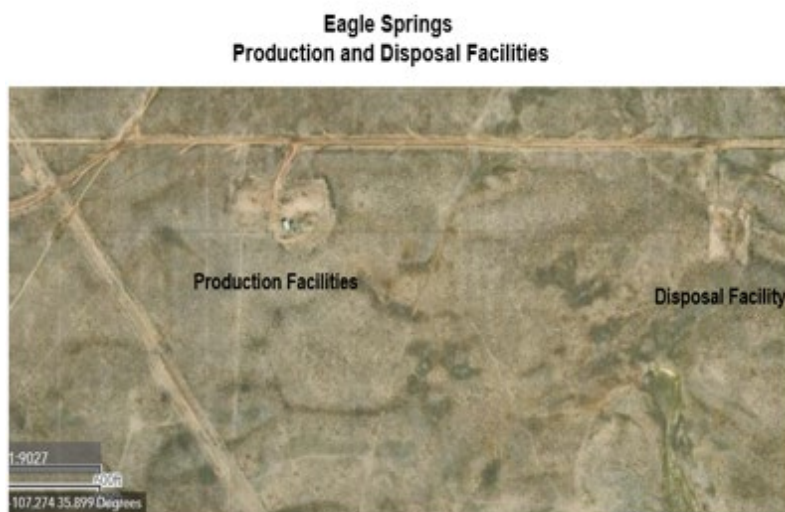
Figure 2. Eagle Springs production and disposal facilities.

The oil is separated from the water and sold while the produced water is currently reinjected into the Eagle Springs 9 Federal SWD #001 (API well # 30-043-21065, Lat. 35.897 Long. 107.271) disposal well which is about a mile away and due east as shown in Figure 2.

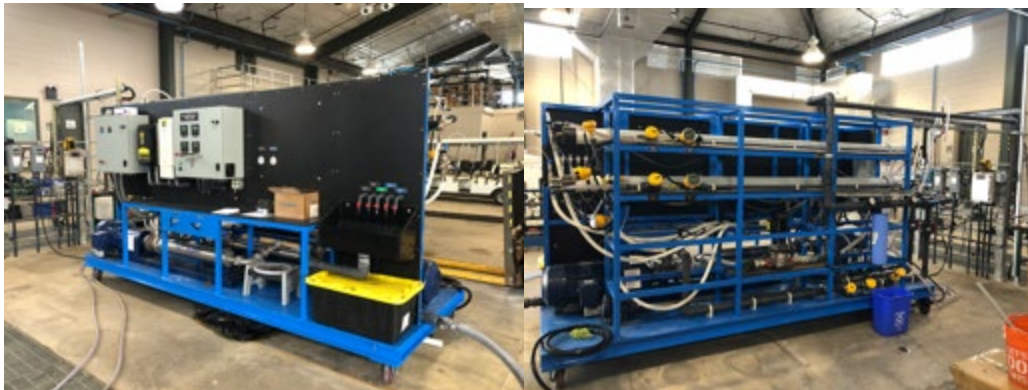
Figure 4. Reverse osmosis treatment system at BGNDRF.

This section provides an overview of the reverse osmosis (RO) brackish water treatment system utilized at BGNDRF to treat the source water from the HPOC Eagle Springs site. As noted, the produced water was pre-treated using a 5-micron filter on site to remove the small concentrations of oils seen in the raw produced water. This is standard procedure for reinjection into a salt water disposal well. Figure 4 below shows the BGNDRF RO system used to treat the Eagle Springs source water. The system was operated by BGNDRF staff in support of this bench-scale test. The system can operate at about 10 gallons per minutes. Once the system was checked out and all systems were tested and verified ready for operation, the 900 gallons of source water was treated in about 90 minutes to two hours.

The system uses spiral-wound membranes that are inserted into the tubes shown on the picture on the right. Under pressure, the water is separated from the salts by the membranes and the clean water (called permeate) is collected in one line, and the rejected salty water (called concentrate) is collected in a second line. The permeate is the treated water that is low in TDS and is used for a number of applications. The concentrate is usually collected and disposed of through injection or evaporation.

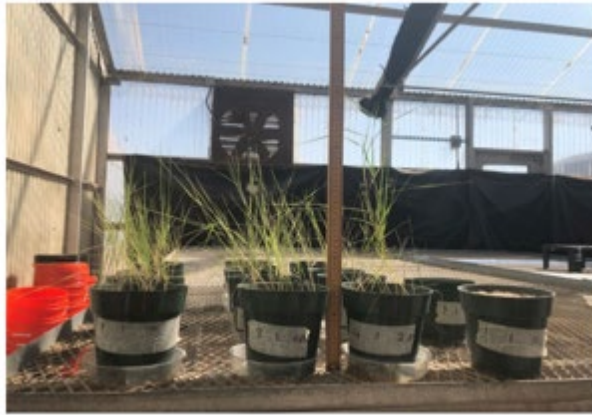
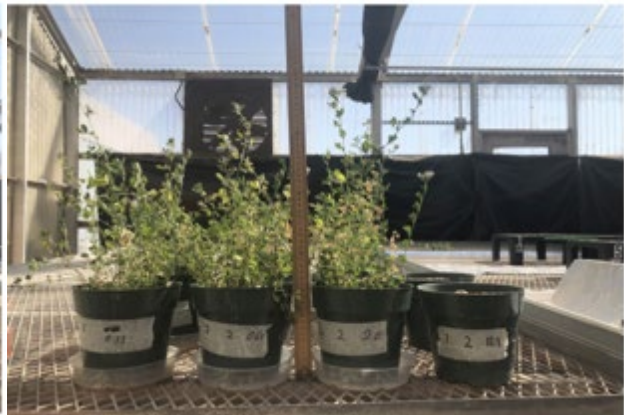
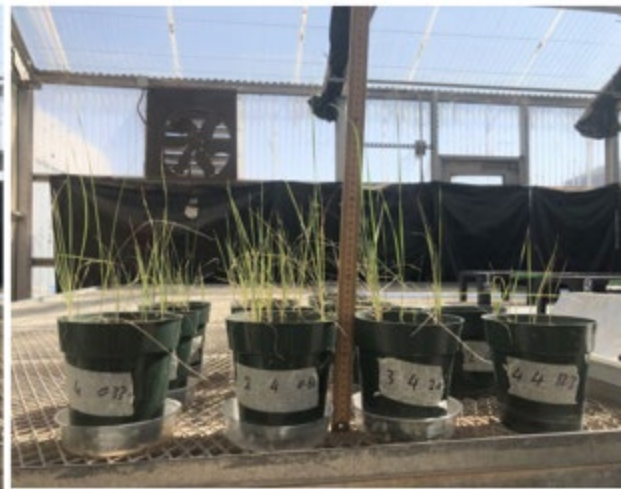
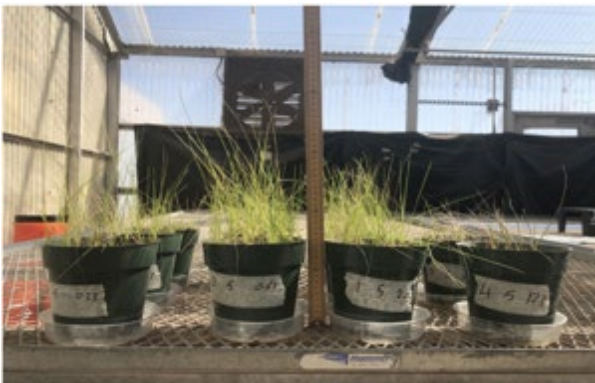
Figure 6. Forage grass growth performance using different waters.

All grasses germinated well with diluted produced water (1400 ppm), conventional city tap water (427 ppm), and RO treated produced water (231 ppm), respectively from left to right in Figure 6 below. Only Tall Fescue germinated with produced water (8610 ppm). This is highlighted in

Figure 6 below. SAR scores by species by water type are detailed in Volume 2. KPIs were not part of the study, nor was carbon sequestration.
